Aden Repair Shop "ARS" has been established since 2001 in Aden with highly qualified engineers. It provides all types of engineering, fabrication maintenance and services. The shop equipped with the best machines and tools for all repairing services requirements

The Following are some of our successful stories in maintenance:

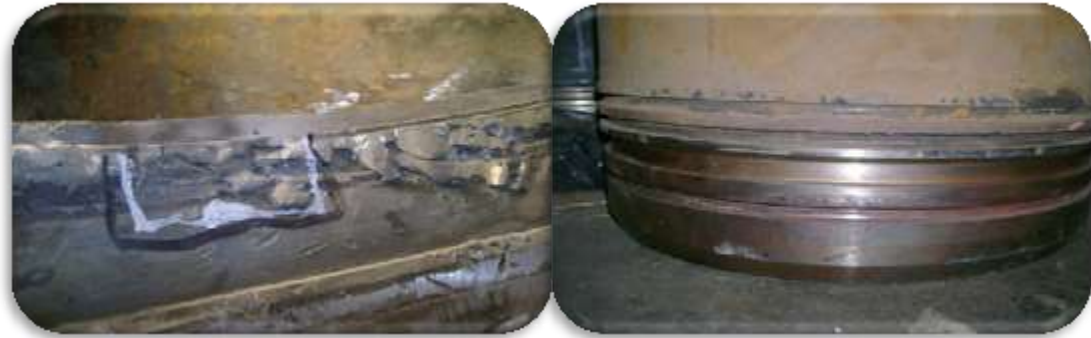
Customer: Sana`a Power Station Deutz Engine

Break in the liner housing (between water chamber & oil chamber)

1. Checkup the required body to specify the proper metal spray products.
2. Cleaning the body from all blemishes before metal spray.
3. Metal spray the proper products.
4. Machining to the required measurements.
5. Last point: Checkup if there is any crack after machining.

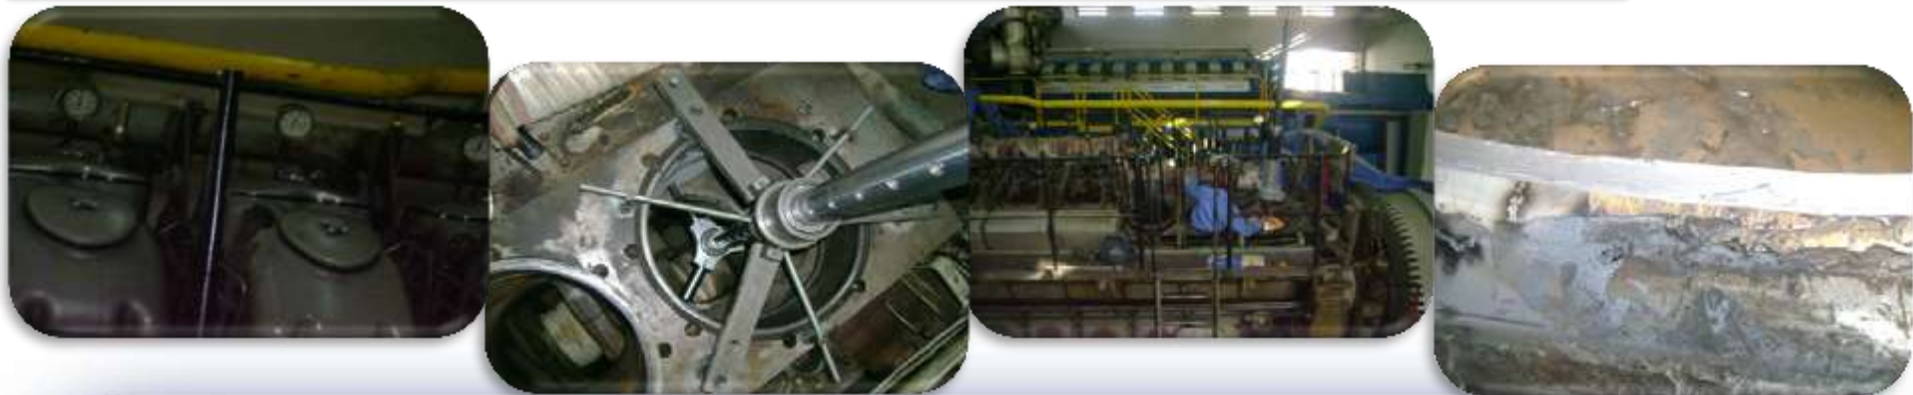
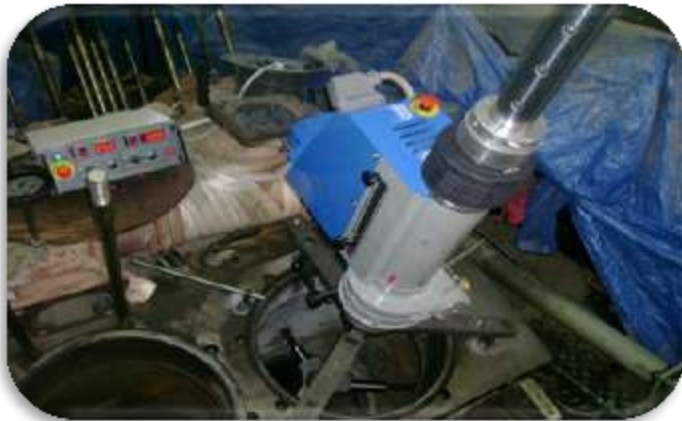
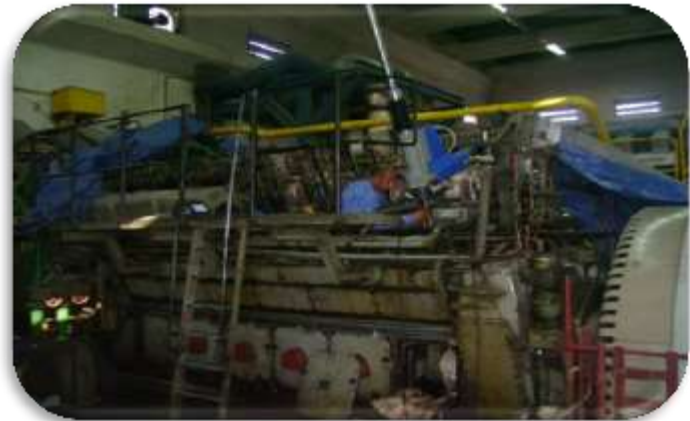
- Work done once the block with all parts are assembled on the engine except the crank shaft and two pistons only.
- Long diameter of liner housing.
- Cast iron welding.

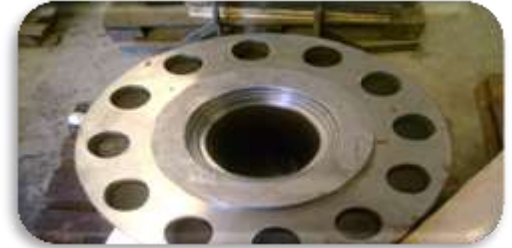
Customer: Yemen LNG GAS Valve

Problem: Leaking of Gas& fuel from the valve side

1. Grinding the surfaced oil and blemishes before metal spray.
2. Crack test for the required area.
3. Choosing the proper Metal spray products with the manufacturer structures.
4. Metal Spray.
5. Machining to the required measurements.
6. Crack test the required area.
7. Last point: Assemble all parts and then press it to 350 bar.

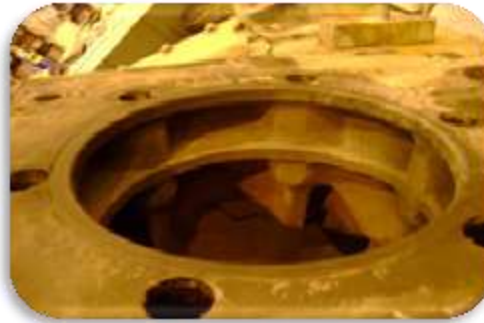
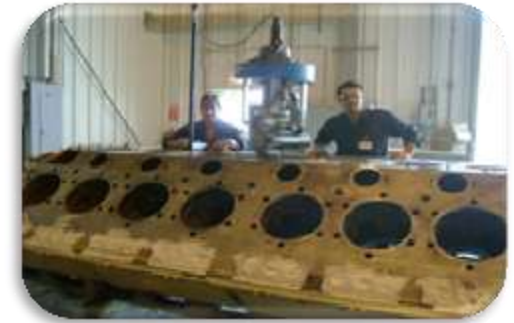
Customer: Canadian Nexen Petroleum Yemen Ruston Engine

Over size liner housing

1. Record the present measurements before machining (ovoid shape).
2. Set the machine on 1" .
3. Cover all holes such as water & oil paths to avoid blemishes entry.
4. Machining to the required measurements.

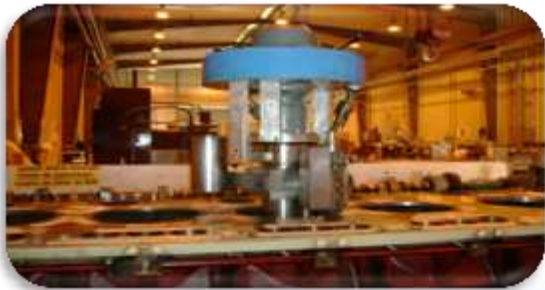
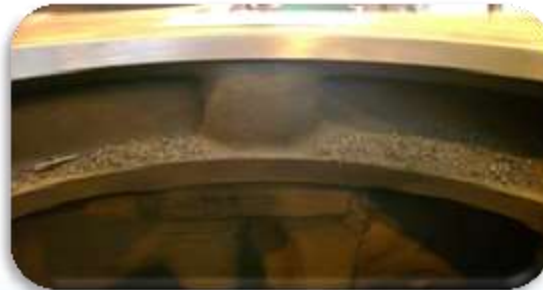
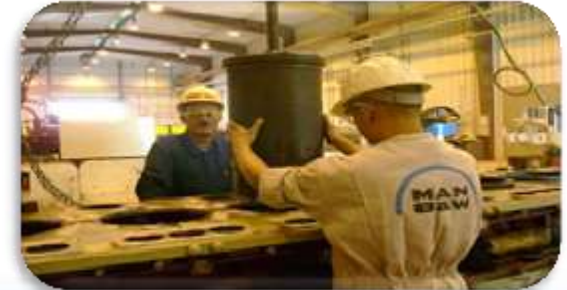
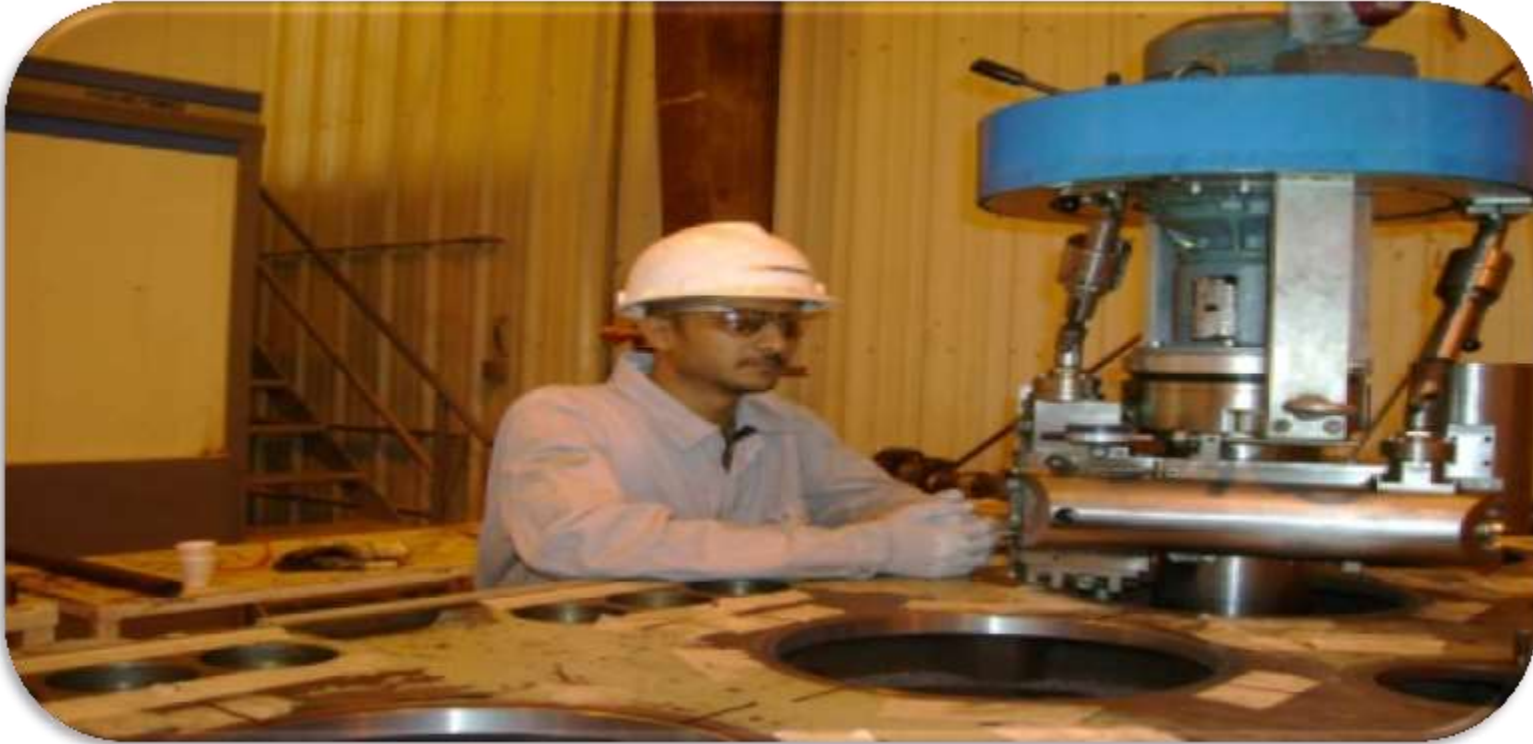
Result:
Successfully running from the first revolution.

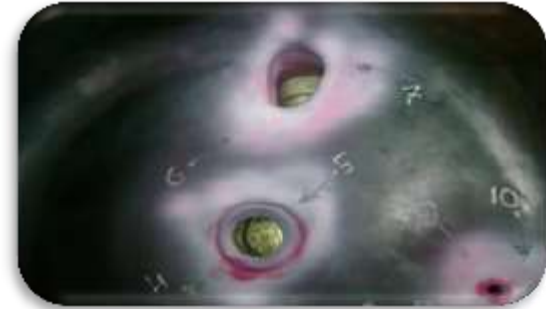
Cracks in the cylinder head

1. Crack test for the cylinder head.
2. Mark the cracks and determine their measurements.
3. Cleaning the body from all blemishes by grinding.
4. Specify the proper metal spray products.
5. Metal spray the proper products.
6. Grinding to the required measurements.
7. Last point: Assemble all parts and then check water pressure & leakage.

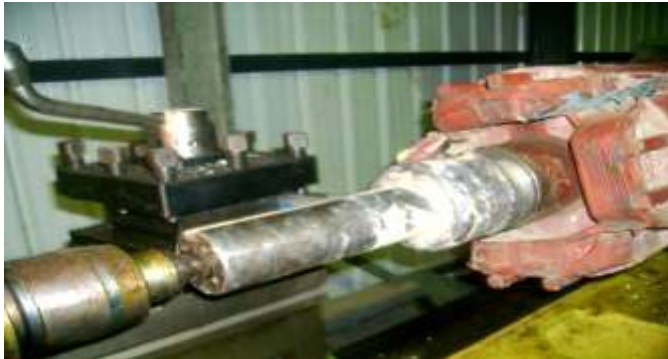
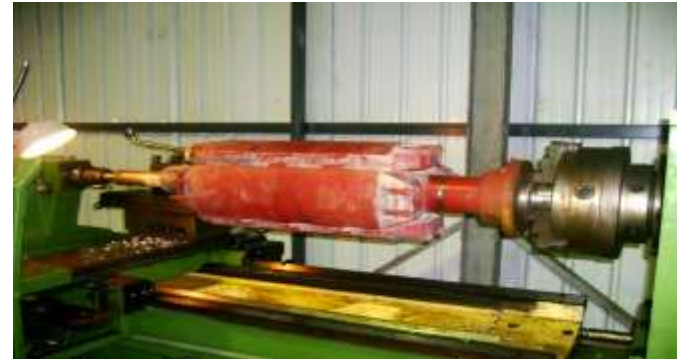
Before Repair

Customer: Canadian Nexen Petroleum Yemen Alternator Shaft

Friction in bearing seat (Wear)

1. Crack test for the cylinder head.
2. Mark the cracks and determine their measurements.
3. Cleaning the body from all blemishes.
4. Specify the proper metal spray products.
5. Metal spray the proper products.
6. Machining to the required measurements.
7. Last point: Do balancing for the alternator shaft.

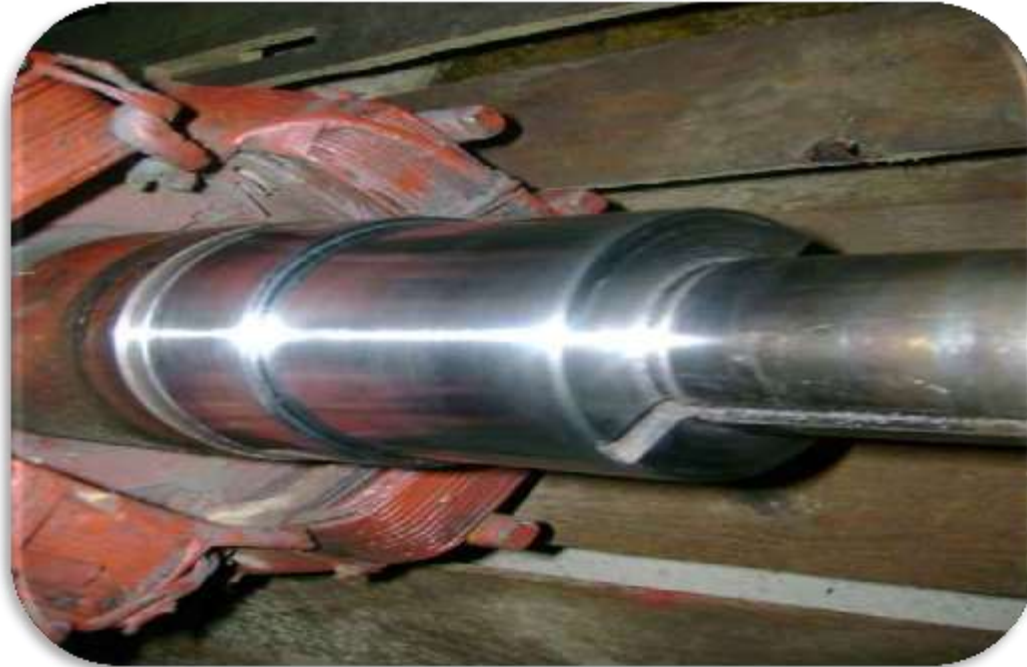
After Repair

Successfully running from the first revolution.
